# Capability of modern tank floor scanning with Magnetic Flux Leakage

**Abstract.** This paper focuses on state-of-the-art Magnetic Flux Leakage (MFL) technology for the inspection of storage tank floors. The primary advantage of the MFL approach is the ability to locate and estimate the size of defects over large areas in a quick and efficient manner. As with any inspection approach, there are limitations which can influence the consistency and reliability of reported defects. However, MFL sometimes appears to be considered as a simple technology screening approach where any competent inspector can interoperate their signals. However, there are misconceptions of the approach that might simply be due to a lack of awareness. Some perceived limitations will be outlined together with suggestions to reduce their effects. To assist with overcoming these parameters further, technological advancements such as a combination of high-resolution scanners and a complementary approach to top and bottom defect discrimination and lead more consistent and reliable inspections.

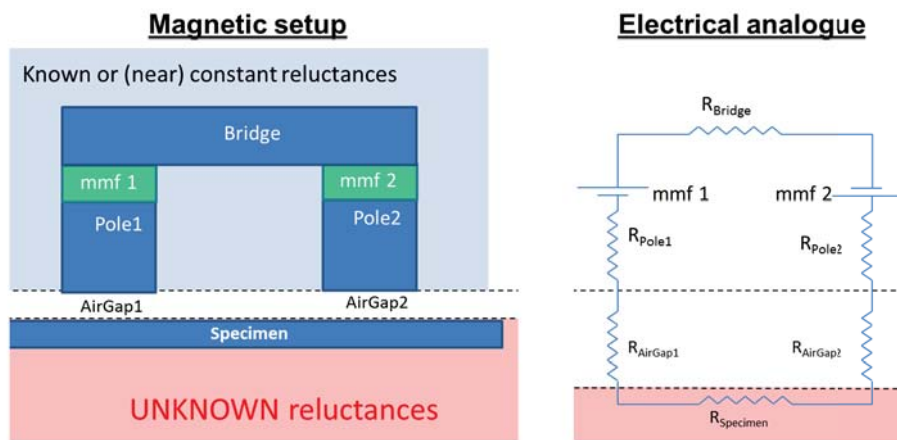
**Fig. 3.** A simple representation of components of a magnetic yoke and its corresponding electrical analogue.

The magnetic yoke shown earlier in Figure 1. is again illustrated in Figure 3. along with its electrical analogue. This is used to describe the approach to perform top and bottom defect discrimination. From the electrical analogue, it can be seen that the equivalent magnetic reluctance of the yoke, both pole pieces and to an extent, the specimen on a uniform plate can be considered known constant parameters. Note that the two magnets  $mmf1$  and  $mmf2$  are represented by voltage sources in the equivalent electrical analogue, and by ignoring potential defect variations in the plate specimen, the only remaining reluctance variations in the magnetic circuit are the consequence of variations to the air-gap. In the presence of a larger air-gap, the magnetic reluctance would increase. This is equivalent to increasing the resistance of the air-gap in the electrical analogue. In the field, air-gap variations can be attributed by several factors including deformations such as rippling of the floor plates and defects on the top surface of the specimen. In the case of top surface defects, changes in the distance between the bottom of the pole piece (either pole 1 or pole 2) would influence the air-gap in a near-linear fashion [3]. In the context of a defect, an increased depth would increase the distance of the air-gap (i.e. the distance under the pole piece) and proportionally increase the reluctance of the air-gap. Thus, a measure of top surface defects with appropriately situated sensors under the poles can be made.

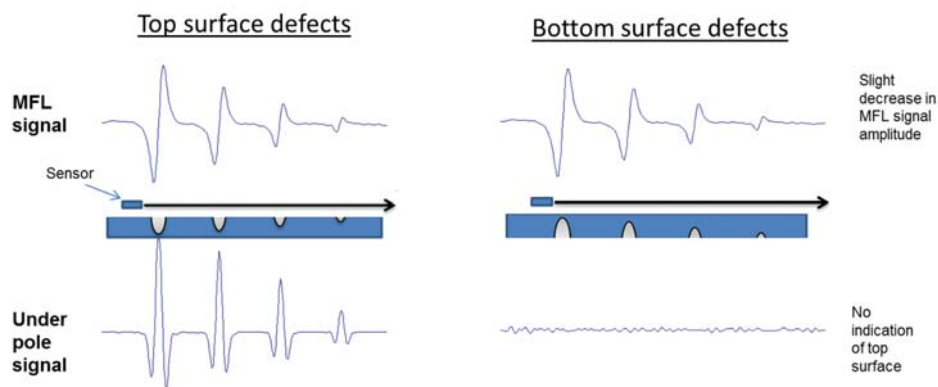
**Fig. 5.** MFL and corresponding START signals from separate top and bottom surface defects.

The under-pole approach has been integrated into the Floormap3DiM tank floor scanner and is able to provide discriminatory information when analysed in conjunction with conventional MFL signals. This complementary technology to traditional MFL tank floor scanning has been designed and developed by Silverwing (UK) Ltd and termed the surface topology air-gap reluctance system (STARS). An example recording of data from both MFL and the STARS coming from defects that reside on the top and bottom of a mild steel plate are shown in Figure 5.. The top-left of Figure 5. illustrates the cross-section along the centre of the steel plate with defects of depths 20%, 40%, 60% and 80%, the first illustration are when these defects are on the bottom and the illustration on the right shows defects and their corresponding MFL signals when the defects are on the top. These defects have semi-sphere profiles and have been machined using a ball-end cutting tool. Traditional bipolar MFL signals are shown on the top of Figure 5. from a single magnetic sensor travelling along the top surface of the plate at a height of 4.1mm. As the defect becomes deeper, the intensity of the MFL signal increases in a proportional manner. Though this is not directly proportional to the depth but more closely related to the volume, as reported by the early work of Saunderson [4]. As
